# **Health Consultation**

### **COMMUNITY LAUNDROMAT**

CITY OF AVA, DOUGLAS COUNTY, MISSOURI

March 8, 2005

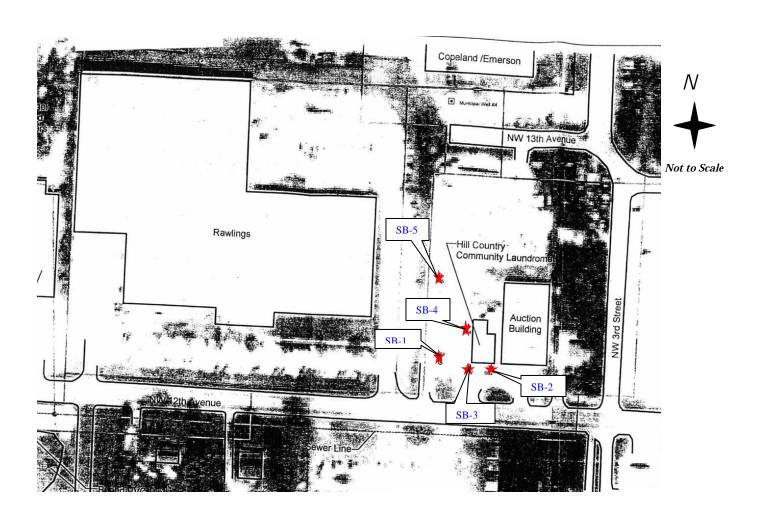
Figure 3: Map of Sampling Locations (Tetra Tech), Community Laundromat Site, Ava; Missouri

The U.S. EPA reviewed soil and groundwater sampling results from a pre-CERCLIS (Comprehensive Environmental Response, Compensation and Liability Act Information System) field investigation that was conducted at the site in July 2001. The findings were discussed in a February 15, 2002, Preliminary Assessment Report. Five soil borings were made across the site, labeled SB-1, SB-2, SB-3, SB-4, and SB-5. A soil sample was collected at a depth of 0 to 2 feet at locations SB-1 through SB-4. A deeper sample was collected at or just above the first occurrence of water. At SB-5 a sample was collected from the 0 to 2 foot interval only. No water was encountered at this location (5). See Figure 3 for a map of the sampling locations.

All soil samples were analyzed for volatile organic compounds (VOCs), semi-VOCs, and metals. No metals or semi-VOCs were detected at levels of health concern. PCE was found at a concentration of 19 micrograms per kilogram ( $\mu$ g/kg) in the soil sample collected from SB-1 at a depth of 17 to 18 feet below ground surface (bgs) near the water table (5). PCE was also found in a concentration of 570  $\mu$ g/kg in a soil sample collected from SB-4 at a depth of 13 to 14 feet bgs (5). Table 1 is a listing of select soil sampling results.

Groundwater samples were collected at SB-1 and SB-2. PCE was found at levels of 1,300  $\mu$ g/L in the SB-1 sample collected at 17 to 18 feet bgs. This sample also contained 1,1,1-trichloroethane (TCA) at a concentration of 12  $\mu$ g/L (5). At location SB-2, PCE was detected at a concentration of 6  $\mu$ g/L at a depth of 17 to 21 feet bgs. Table 2 is a listing of select water sampling results.

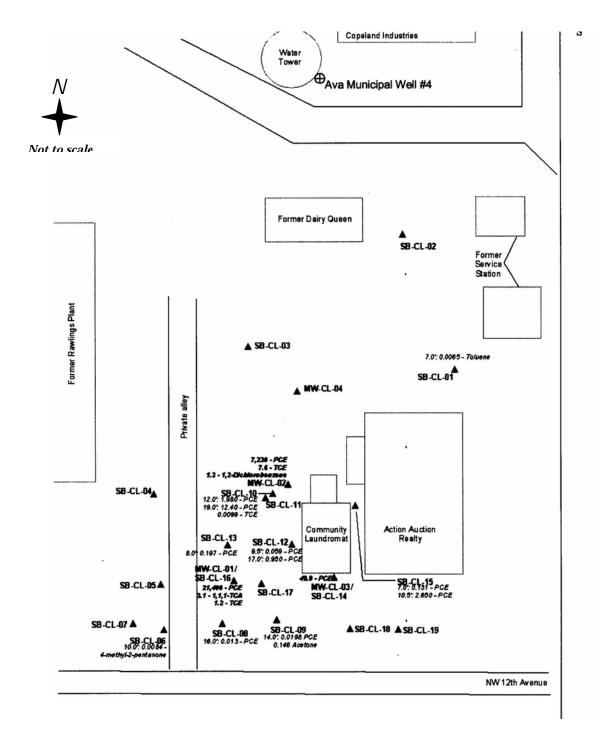
Figure 4: Map of Sampling Locations (MDNR), Community Laundromat Site; Ava, Missouri

In early 2002 the Missouri Department of Natural Resources (MDNR) conducted a removal assessment sampling investigation at the site. During this sampling event, a total of 28 subsurface soil samples were collected from the sites labeled SB-Cl-01 through SB-Cl-19. PCE was detected in 10 soil samples from six locations (1). Levels of PCE ranged from 13  $\mu$ g/kg to 12,400  $\mu$ g/kg (1). During this sampling event a sample was also collected from the "old spring house." The concentrations found (37.3  $\mu$ g/L of PCE and 2.6  $\mu$ g/L of TCE) indicated that the levels have not changed significantly since May 2001 (1).

The primary concern relating to the PCE in the on-site soil is that the concentrations exceed benchmarks for migration or leaching to groundwater, both Cleanup Levels for Missouri (CALM) (100  $\mu$ g/kg for PCE) and EPA Soil Screening Levels for Migration to Groundwater (3  $\mu$ g/kg for PCE) (1). Exceeding the benchmarks suggests that sufficient contamination is present to move into the groundwater. The main concern of this contaminant movement is the proximity of the public drinking water supply wells. Table 1 is a listing of select soil sampling results.

Four micro monitoring wells were drilled on-site during the MDNR sampling event, numbered MW-Cl-01, MW-Cl-02, MW-Cl-03, and MW-Cl-04. Groundwater samples were taken from MW-Cl-01, MW-Cl-02, and MW-Cl-03 and analyzed for VOCs. MW-Cl-04 did not maintain enough water for a sample to be taken. PCE was detected in the water sample from all three wells at levels significantly above the Maximum Contaminant Level (MCL) of 5  $\mu$ g/L. An MCL is the maximum concentration of a chemical U.S. EPA will allow in public drinking water. MW-Cl-01 is located downgradient of the spill outside of the main entrance and contained the highest concentration of PCE (21,400  $\mu$ g/L). TCE was also detected in MW-Cl-01 and MW-Cl-02. See Figure 4 for a map of the soil and groundwater sampling locations. Table 2 is a listing of select water sampling results.

3. Because the Community Laundromat site has been determined to be a continuing source of contamination in soil and groundwater, EPA/MDNR/Responsible Parties should consider removal actions to mitigate or prevent future exposures.
